**THE TENNESSEE VALLEY
AUTHORITY'S KINGSTON ASH SLIDE:
EVALUATION OF POTENTIAL
CAUSES AND
UPDATES ON CLEANUP EFFORTS**

HEARING
BEFORE THE
SUBCOMMITTEE ON
WATER RESOURCES AND ENVIRONMENT
OF THE
COMMITTEE ON
TRANSPORTATION AND
INFRASTRUCTURE
HOUSE OF REPRESENTATIVES
ONE HUNDRED ELEVENTH CONGRESS
FIRST SESSION

JULY 28, 2009

FINAL REPORT – INSPECTION 2008-12283-02 – REVIEW OF KINGSTON FOSSIL PLANT ASH SPILL ROOT CAUSE STUDY AND OBSERVATIONS ABOUT ASH MANAGEMENT

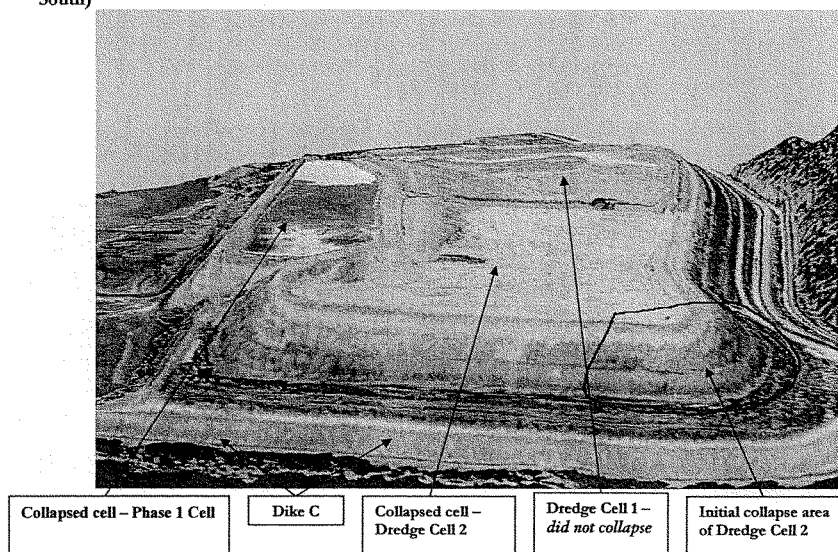
Figure 2: Three-Dimensional View of TVA Kingston Impoundment Pre-Collapse (Facing South)¹

At 1 a.m., on Monday, December 22, 2008, a retaining wall failed at a coal ash retention pond at TVA's Kingston Fossil Plant. The breach in the retaining wall resulted in the release of 5.4 million cubic yards of ash and 327 million gallons of water onto land adjacent to the plant, as well as into the nearby Clinch and Emory Rivers. The surface impoundment in question was comprised of Dredge Cell 1, Dredge Cell 2, and the Phase 1 Cell. The northern edge of the impoundment was bounded by a 200 foot wide setback, and then a final dike, Dike C (see Figure 2). The dikes were

initially built of naturally silty clays, and then bottom ash and fly ash. On December 22, 2008, Dredge Cell 2 and the Phase 1 Cell collapsed, but, for the most part, Dredge Cell 1 remained intact.

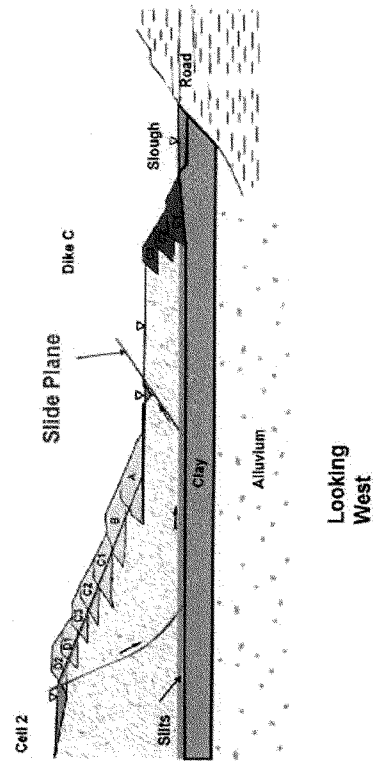
Figure 3

Stage 1 - Initiation of Failure at North Side of Dredge Cell 2

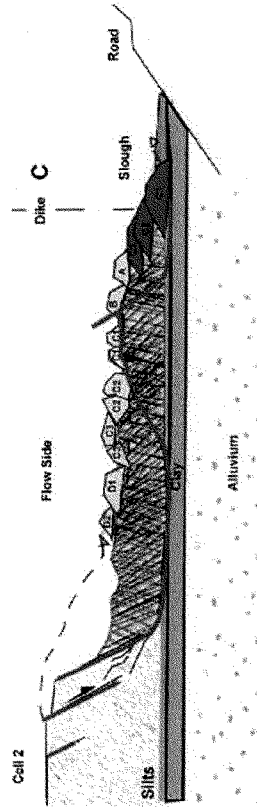
Figure 4

Stage 2 – Ash & Dikes A thru D2 Pile Up Against Dike C. This Surge and increased Ash Pressure Causes Dike C to Fail

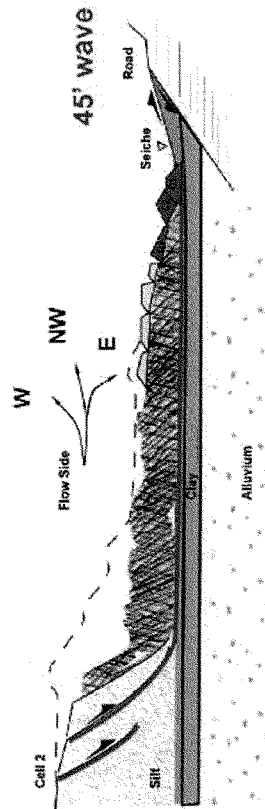
Figure 5

Stage 3 – Progressive Failure Southward that Fails North Dikes A thru D2 Back to Cell 1 Divider Dike. 5.4 Million CY Fill Sloughs and Reservoir

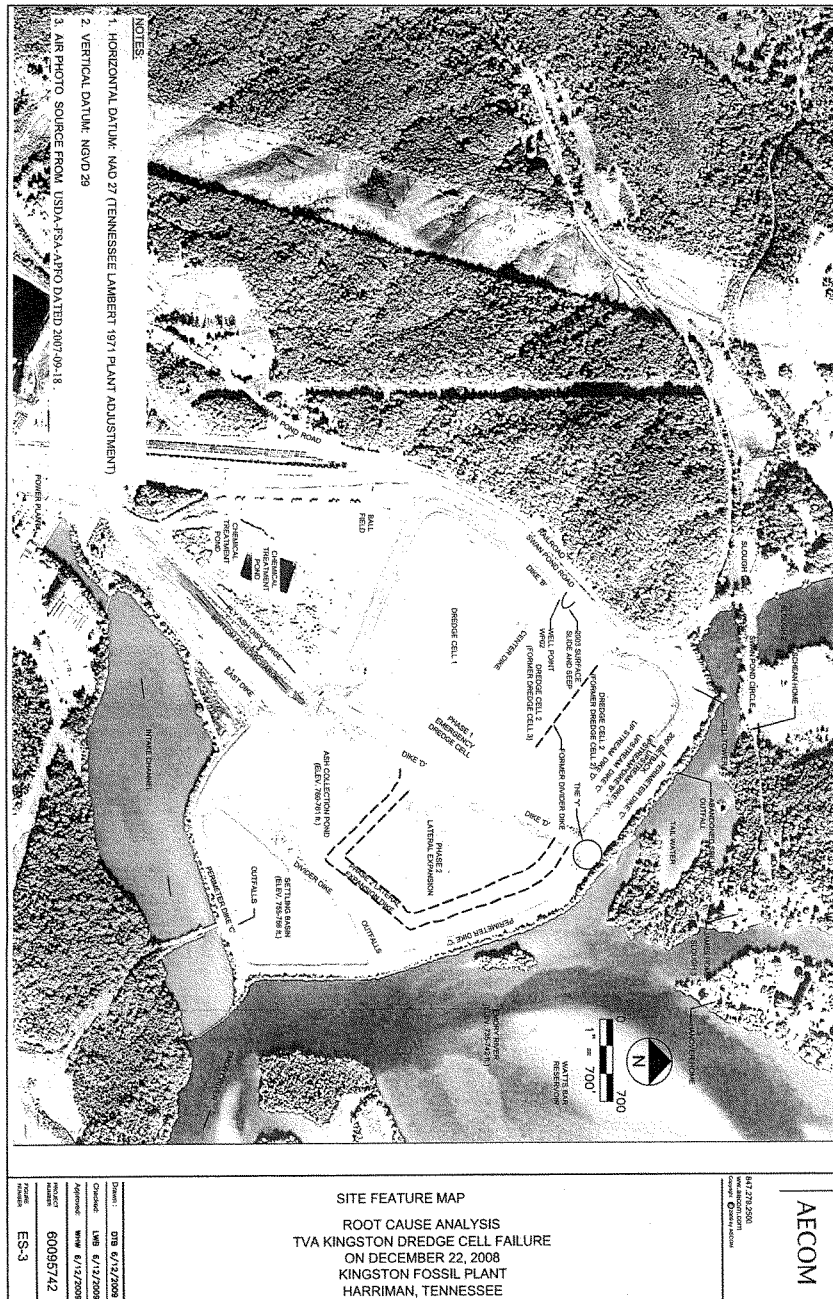
The north end of Dredge Cell 2 was on the verge of failure due to the high stresses and creep in the loose wet layer of weak slimes. The deformation of the slimes in turn caused the overlying collapsible wet ash to liquefy. Figures ES_6 through ES_11 following this Executive Summary show AECOM's orthographic interpretation of the initial failure location and apparent failure sequence at the north end of Cell 2. Failure of the Kingston dredge cells was sudden and complex in nature due its geographic setting and being built within the Watts Bar Reservoir after the lake was formed. It took a forensic type study to determine the propensity of the ash to liquefy at low strain levels when the material cannot drain and thus becomes undrained, and to locate the slide plane in the unusual, creep susceptible, low undrained shear strength slime layer that underlies Cell 2. In AECOM's opinion, subsurface conditions at the dredge cells were unusual and rarely found. The consequence of failure in the slimes led to the collapse of the dredge cell and loss of the saturated contents of the ash landfill due to the breach of perimeter Dike C. Figures ES_12, ES_13, and ES_14 show AECOM's interpretation of progressive failure at the northwest end of Cell 2 and containment Dike C.

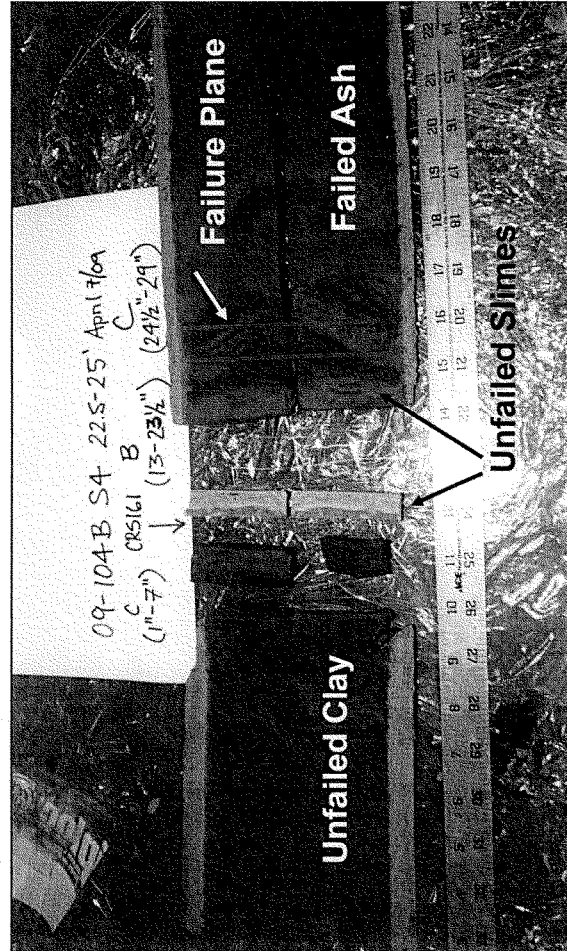
¹ Christopher J. Lewis, P.E. is a Geotechnical Subconsultant of MM&A and is employed by D'APPOLONIA, ENGINEERING DIVISION OF GROUND TECHNOLOGY, INC., Monroeville, Pennsylvania.

Photos of Slide Plane in Slimes at 09-104B

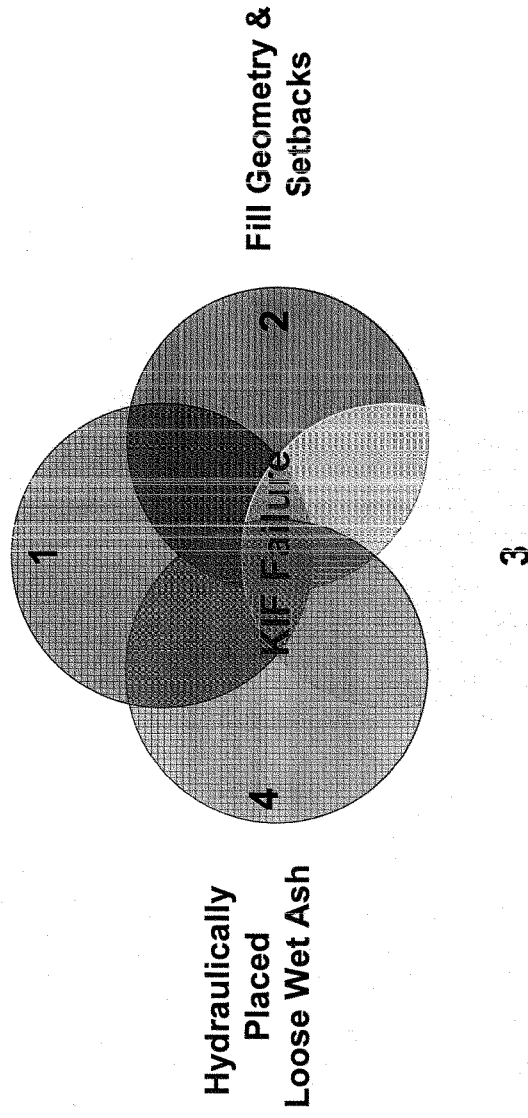
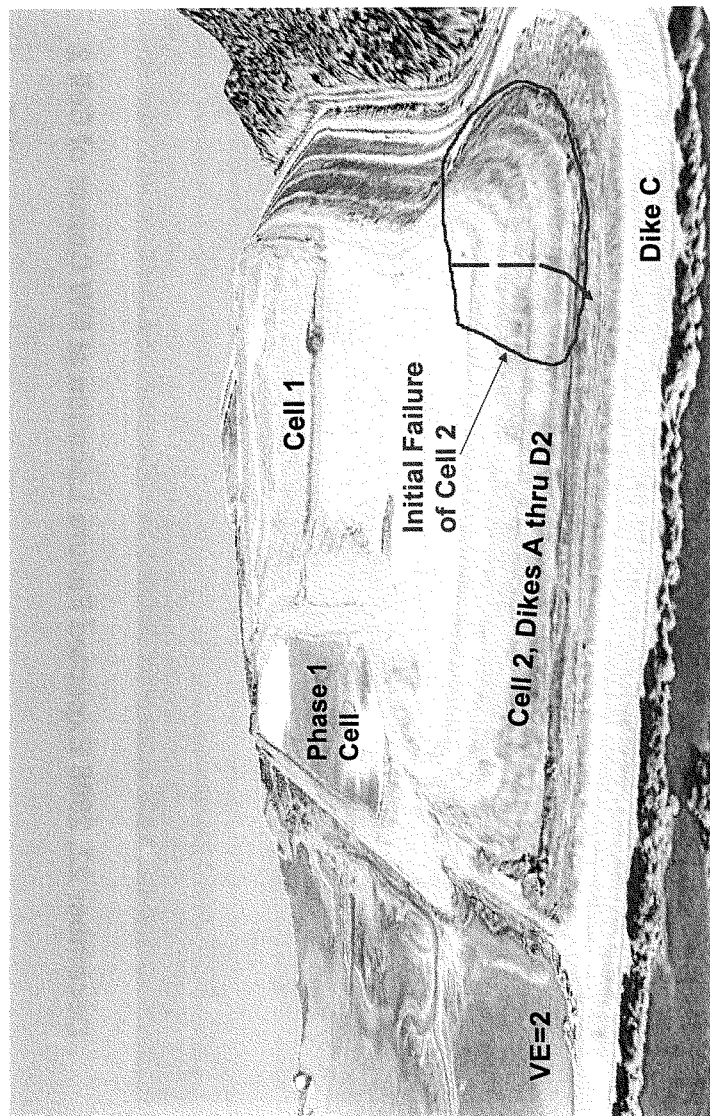
Kingston Dredge Cell Failure Conditions

Increased Loads Due to Higher Fill

December 22, 2008 Expected Failure Location at NW Corner of Cell 2

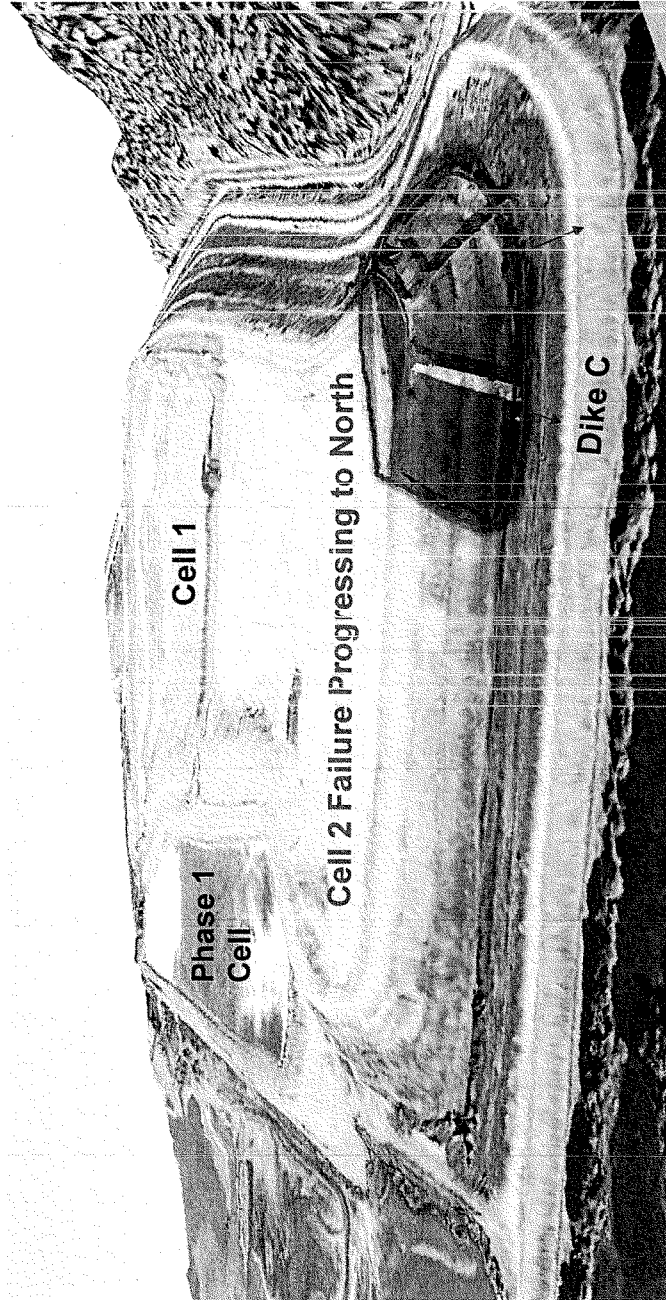
Figure ES_6

December 22, 2008 Expected Failure Location at NW Corner of Cell 2

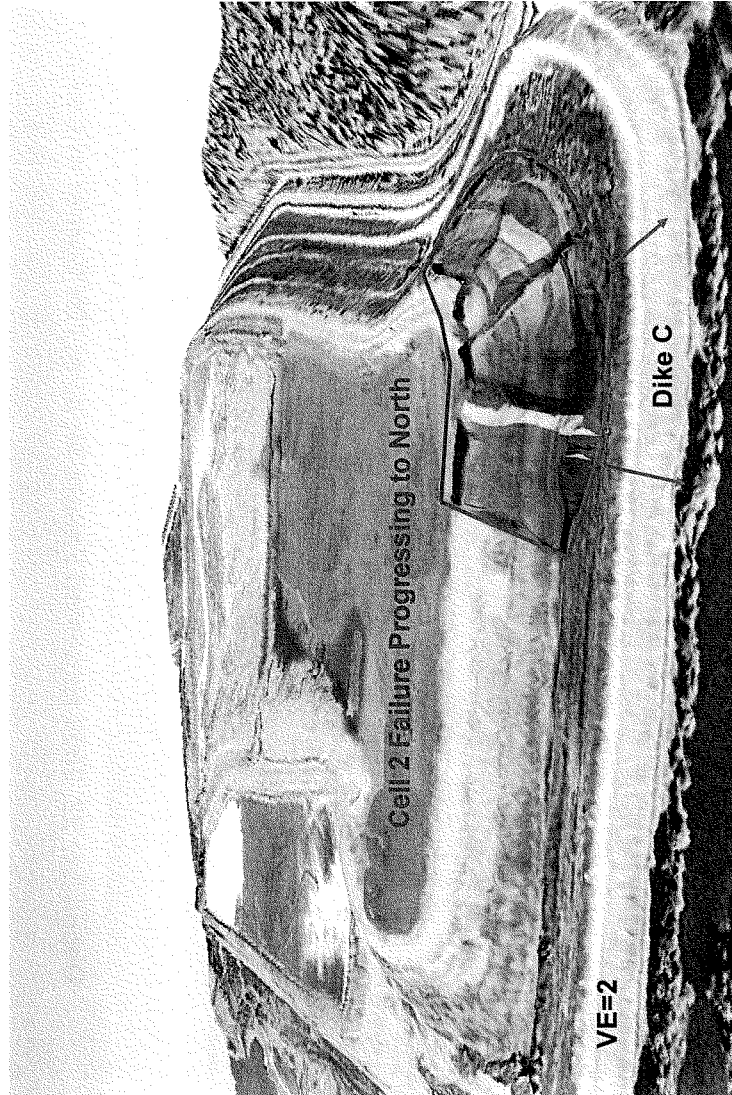
Figure ES_7

December 22, 2008 Expected Failure Mode at NW Corner of Cell 2

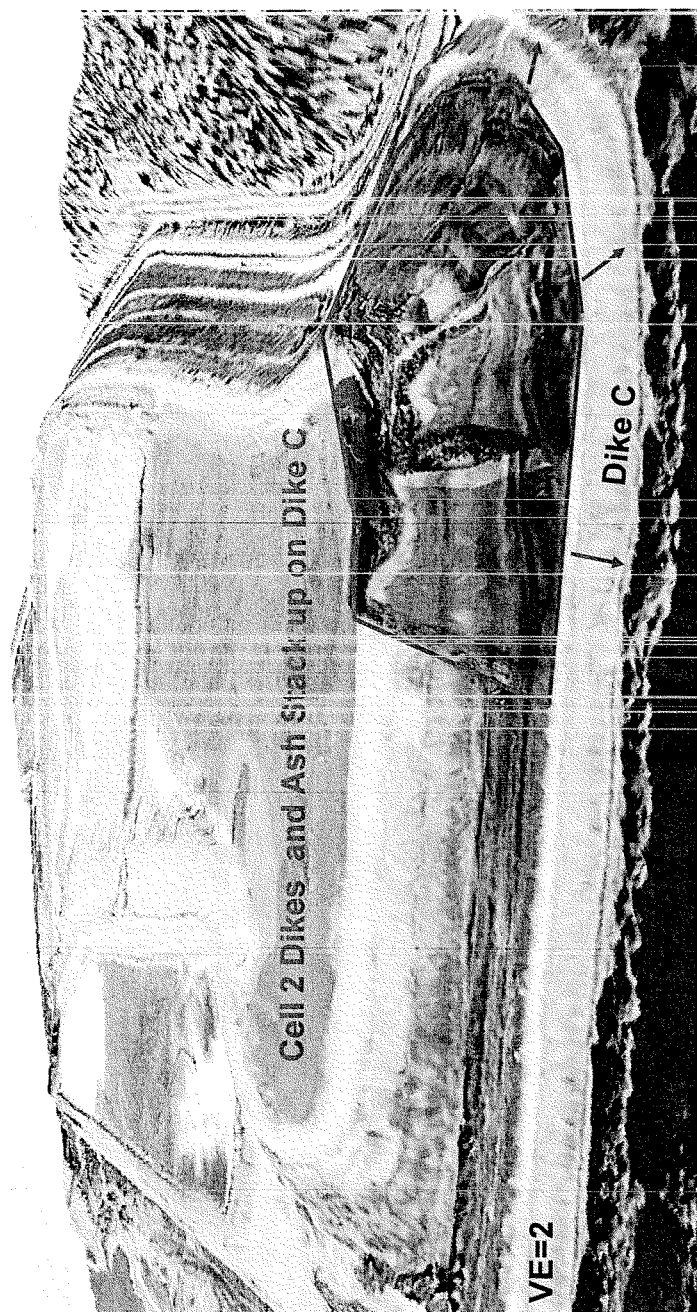
Figure ES_8

December 22, 2008 Expected Failure Mode at NW Corner of Cell 2

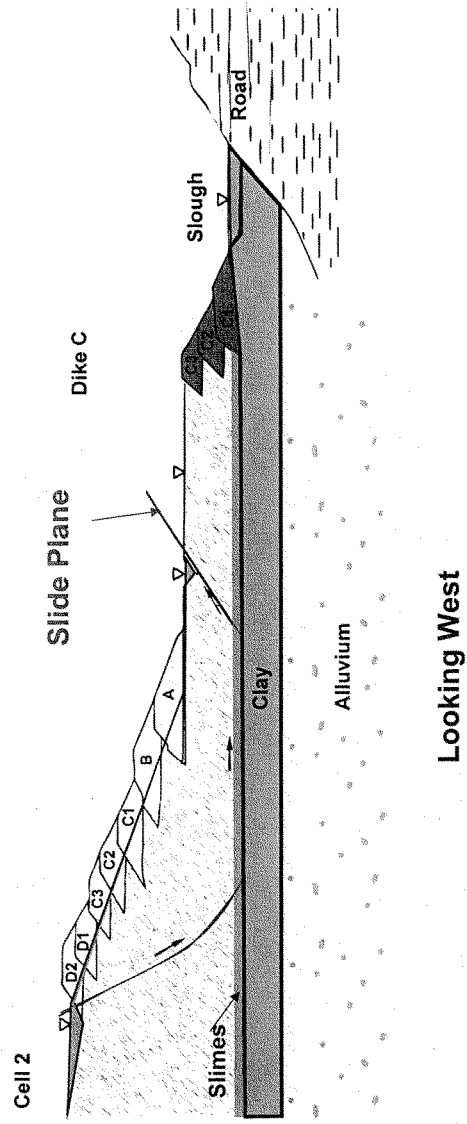
Figure ES_12

Stage 1 - Initiation of Failure at North Side of Dredge Cell 2

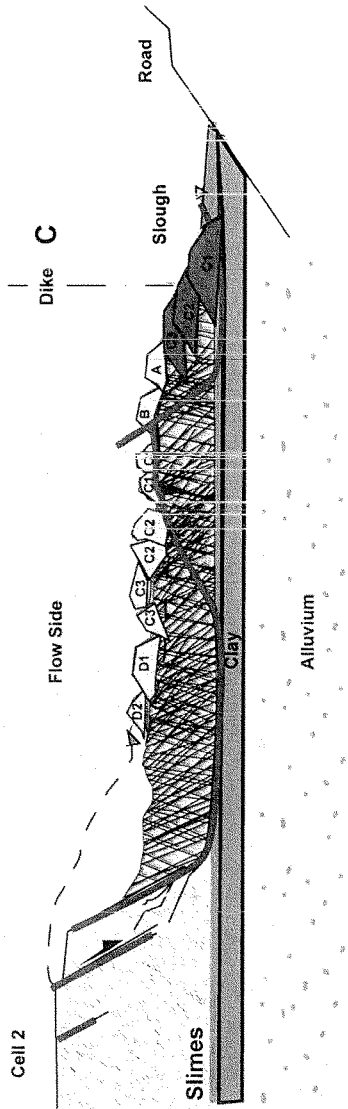
**Stage 2 – Ash & Dikes A thru D2 Pile Up Against Dike C.
This Surge and increased Ash Pressure
Causes Dike C to Fail**

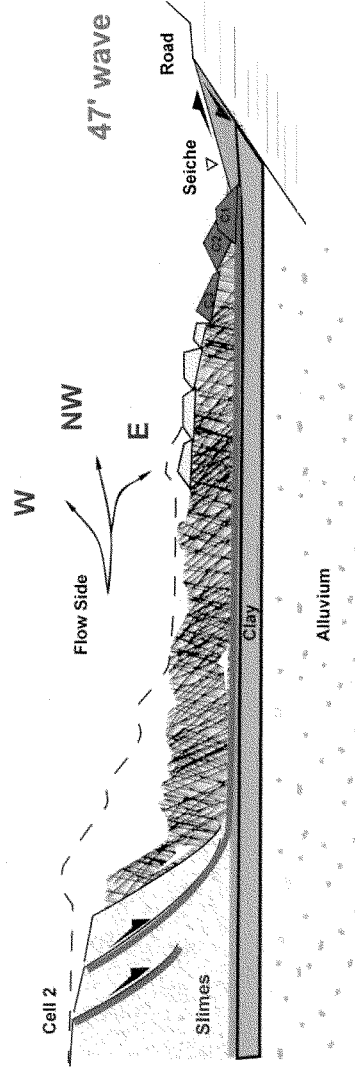
**Stage 3 – Progressive Failure Southward that Fails North
Dikes A thru D2 Back to Cell 1 Divider
Dike. 5.4 Million CY Fill Sloughs and Reservoir**

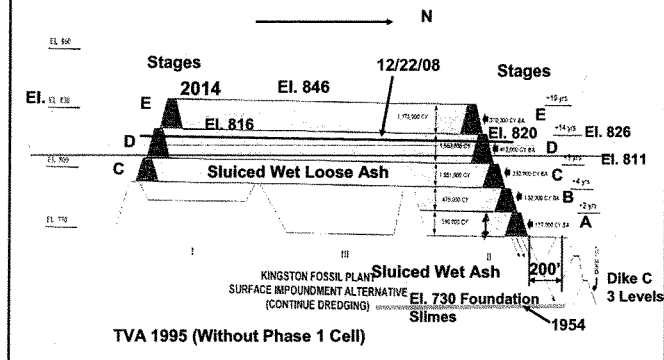
Active Cell 2 Filling, Dike Containment, and Foundation Supporting Loose Wet Ash

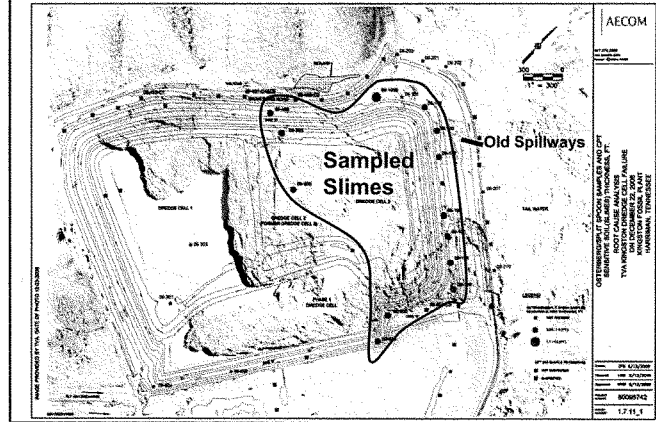
Location of Silt and Flyash Slimes Under Cell 2
